SHERIFFDOM OF LOTHIAN & BORDERS AT EDINBURGH

[2025] FAI 22

DETERMINATION

CARLOS HERNAN CORREA PALACIO

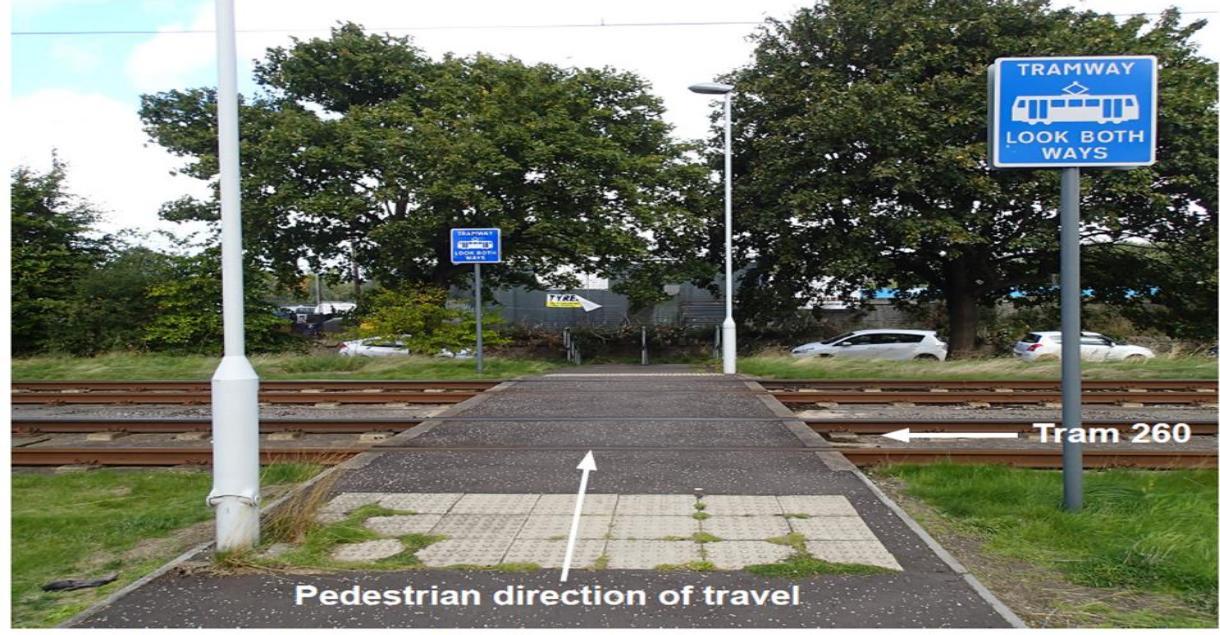
Figure 3: The approach to the footpath crossing looking north

accepted that had there been a greater degree of oversight of the conduct of the said manager, the extensive failures to carry out suitable risk assessments would have been identified and addressed prior to the accident. I would reiterate that the purpose of an Inquiry is not to determine fault or to apportion blame to any particular individual. I should therefore make it clear that the failings attributed to, and accepted by ETL for the purposes of this Inquiry, were at an organisational level. This is consistent with ETL's guilty plea in respect of the criminal proceedings as detailed at paragraph [60] above. [94] Focusing specifically on the design and layout of the crossing, the guidance available in RSP2 detailed at paragraph [40] above provided that fencing or pedestrian guard rails should be provided where necessary to guide pedestrians to face oncoming trams before they cross the track. No such fencing or guard rails were provided at the crossing.

At time of the accident on 11 September 2018

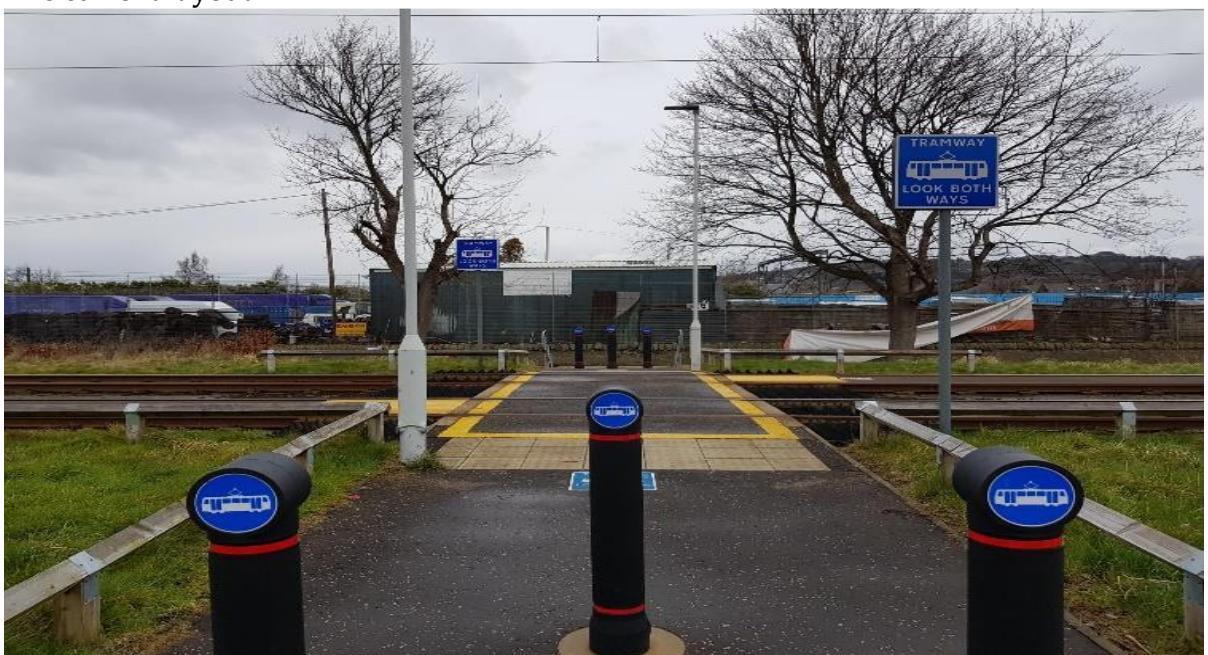
The current layout

[125] On the basis of the evidence before the Inquiry, I do not consider that any recommendations fall to be made. The accident was fully investigated by the RAIB. It made what it regarded as appropriate safety recommendations in relation to both ETL and the wider UK tram industry. These are detailed at paragraph [59] above. I am satisfied that these comprehensive and wide-ranging recommendations have been fully implemented and have led to significant improvements both at ETL and within the UK tram industry more broadly. I have summarised the steps taken in this regard at paragraphs [61] to [73] above. An image showing the current configuration of the crossing in question is also produced at Appendix I.
