**SHERIFFDOM OF GRAMPIAN, HIGHLAND AND ISLANDS AT ABERDEEN**

**[2026] FAI 34**

DETERMINATION

**ROBERT EAN MCLEOD**

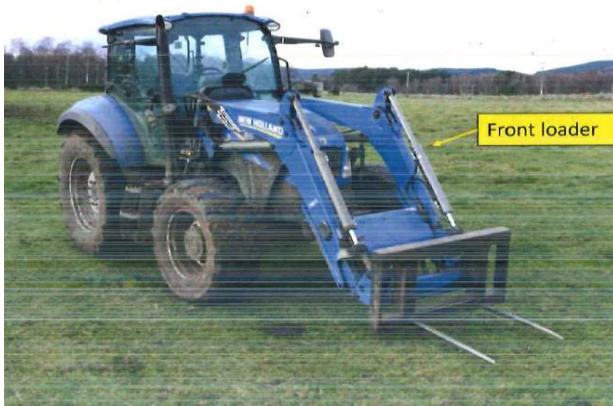
[18] Ean McLeod drove a New Holland tractor. The tractor had a front loader attached which was fitted with a double tine bale spike. The two metal spikes were

each 70cm in length. Ean McLeod used the spikes to spear a hay bale, which he then carried to Ennochie Farm. Robert McLeod followed in a separate vehicle. A photograph of the tractor with front loader is shown below<sup>1</sup>.

[31] The maximum height from the ground of the tine spikes on the front loader of the tractor was 2.87 metres. The spikes could tilt from the horizontal to a maximum of 59 degrees to allow a hay bale to slide off. In order for the edge of the ring feeder (when flipped up on its side) to pass underneath the front loader, the spikes on the front loader would require to be at least 2.16 metres above the ground (this being the hypotenuse of the right-angled triangle formed with the side and diameter of the ring feeder).

[40] If the spikes of the front loader had been lower when the hay bale slid off, they may have blocked the edge of the ring feeder when it flipped up and prevented it hitting Robert McLeod. Generally, it will be safer to let a hay bale slide from the spikes from a lower height. However, I make no finding that a reasonable precaution would be to ensure a hay bale is released from a height which would ensure the spikes would block

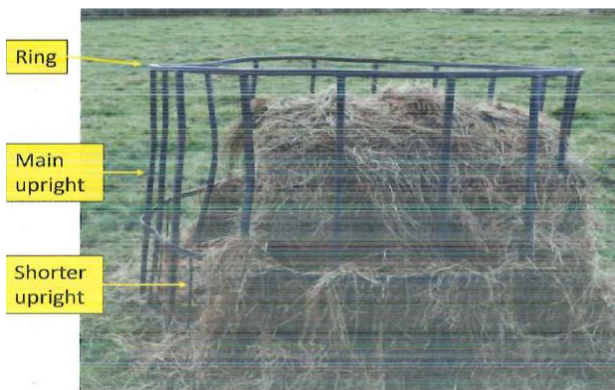
[19] In the cattle field there was a galvanised metal circular livestock ring feeder. It sat, unsecured, on level ground. It was 1.2 metres high and 1.8 metres in diameter. A photograph of the ring feeder with a hay bale inside is shown below.

[20] The hay bale was to be deposited into the ring feeder. The hay bale was wrapped in a wire mesh around its circumference to maintain the bale's shape during handling and transportation.

[23] As the bale slid from the spikes, it struck the top edge of the side of the ring feeder closest to Robert McLeod. This caused the other side of the ring feeder (that closest to the tractor) to rear up and flip over in Robert McLeod's direction and strike him on the head. Robert McLeod fell to the ground and was rendered unconscious.

[29] The ring feeder was of a metal welded construction. It was 1.8 metres in diameter and 1.2 metres in height. It was slightly distorted/damaged. This was assessed to be attributable to normal wear and tear. The approximate weight of the ring feeder was 80 kilograms.

[30] The diameter of the hay bale was 1 metre. It was appropriately proportioned to fit into the ring feeder. The estimated weight of hay bale was between 200 and 300 kilograms. The hay bale was therefore approximately 2.5 to 3.5 times the weight of the ring feeder and was capable of causing the ring feeder to flip if it struck its edge.
