SHERIFFDOM OF GLASGOW AND STRATHKELVIN AT GLASGOW

DETERMINATION OF SHERIFF PRINCIPAL C D TURNBULL

UNDER THE INQUIRIES INTO FATAL ACCIDENTS AND SUDDEN DEATHS ETC
(SCOTLAND) ACT 2016

**GARY LOUIS ARTHUR; ANTHONY LYNDON COLLINS; JOSEPH ROBERT CUSKER;
COLIN GIBSON; ROBERT JAMES JENKINS; JOHN McGARRIGLE; SAMUEL BELL
McGHEE; KIRSTY MARY NELIS; MARK EDWARD O'PREY; and DAVID IAIN TRAILL**

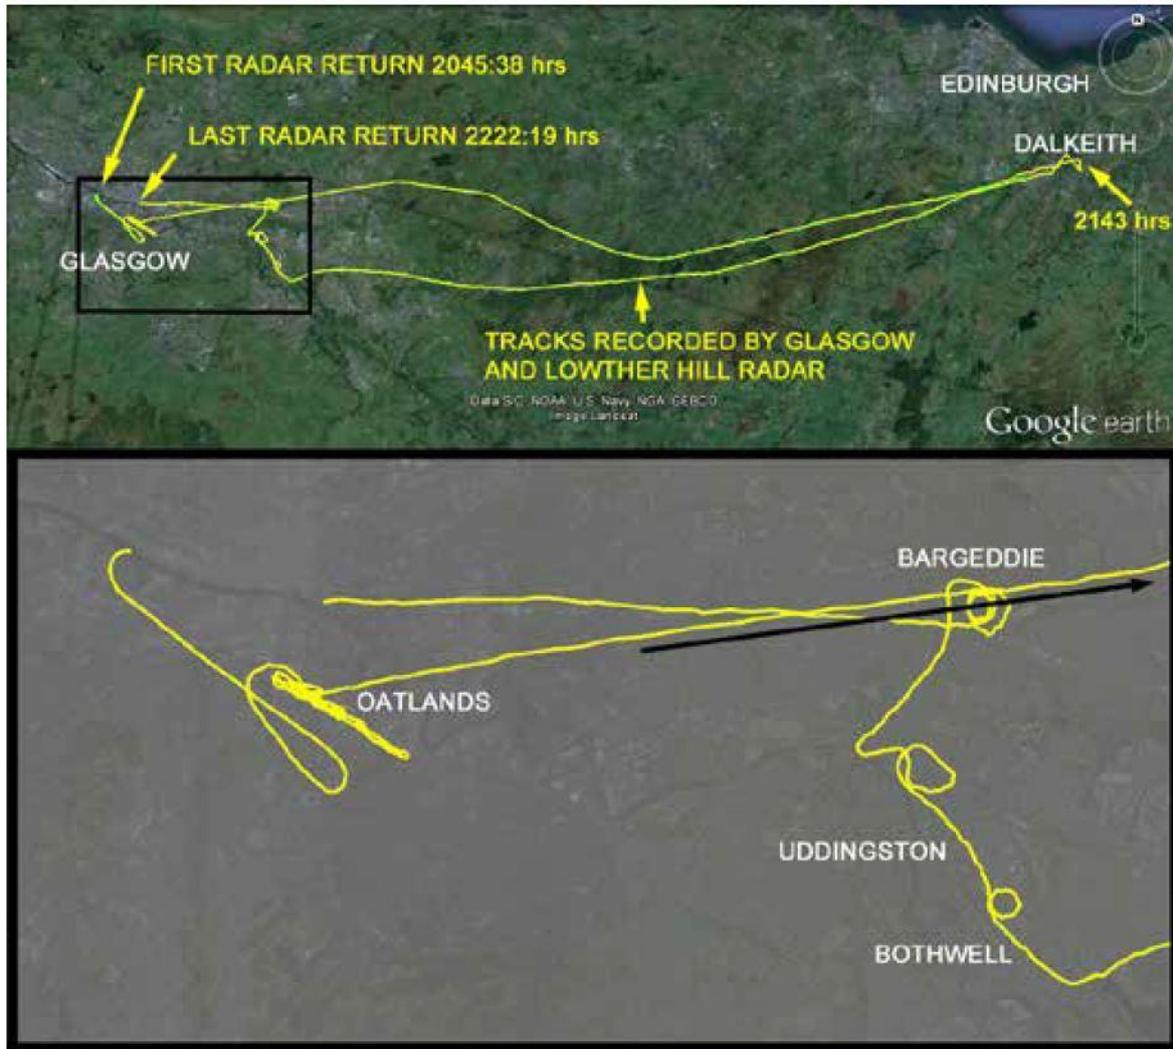
Appendix 3

Overview of G-SPAO's Final Flight Path

[Reproduced from AAIB report – Figure 1, page 7]

[43] The AAIB Report (see Part 9 below) contains a description of the final flight of G-SPAO at paragraph 1.1.2. This was created from an amalgamation of recorded data and other evidence obtained by the AAIB. Additionally, the AAIB produced (see Figure 1 on page 7 of the AAIB Report) an overview of G-SPAO's flight path, which shows G-SPAO's track from its point of departure to the location of the accident.
